# WOODEN WALLS

# EXTERIOR WALLS of WOOD

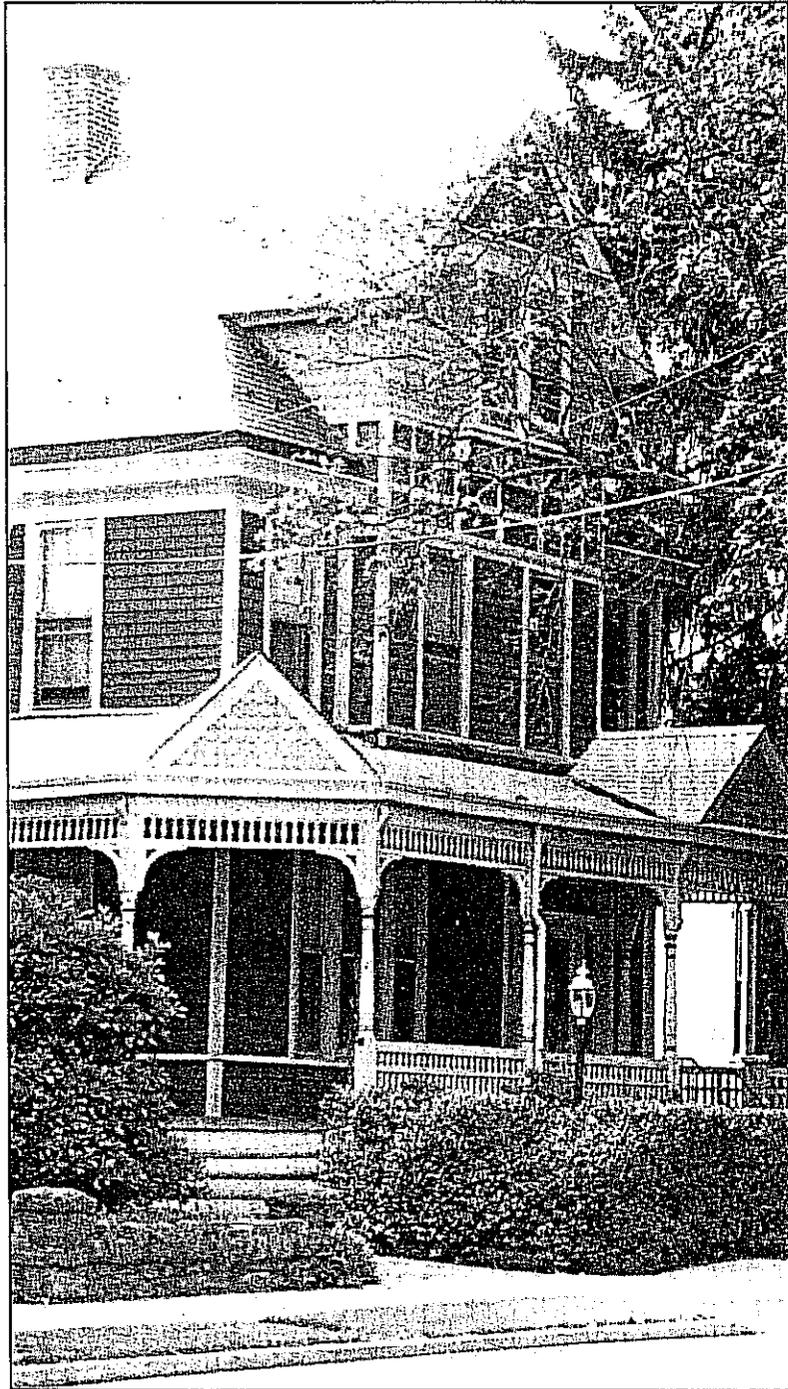
The house at 204 Carlisle Street features wood in a variety of sidings, facings and ornament.

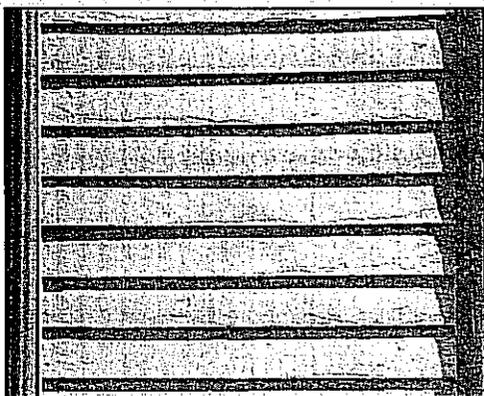
Clapboard (pictured at the right), also called bevel siding, lap siding, and weatherboard, is composed of single boards, tapered from the top to the bottom, and nailed in overlapping fashion. Boards are typically about 4" wide and the overlap produces a distinctive shadow effect that has not been successfully reproduced by artificial siding.

Wood clapboards at 139 Carlisle Street.

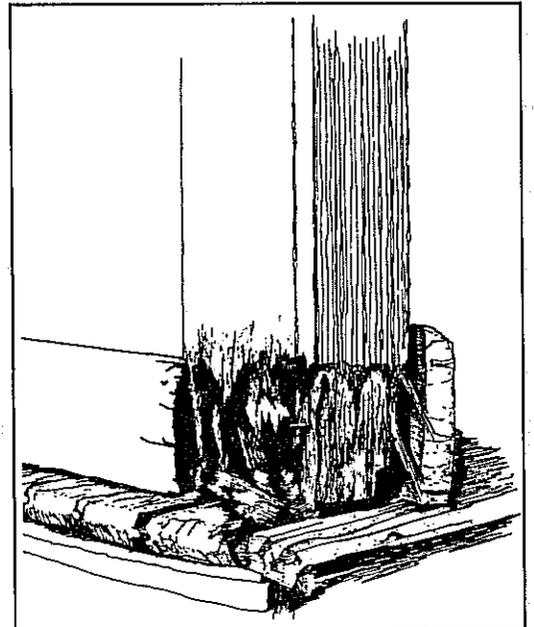
**Brown Rot** is a serious form of rot resulting from excess moisture and fast-moving inner deterioration of the wood. The result is a crumbly surface that turns wood a brown color. Cracks are visible across the grain of the wood, and they permit greater amounts of water to penetrate, which results in greater deterioration.

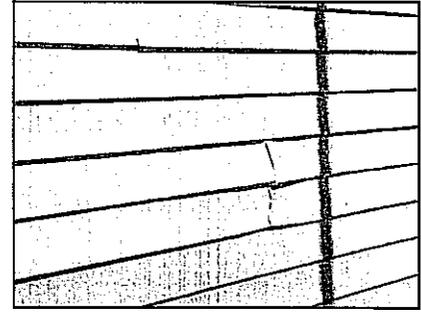
Vinyl siding is susceptible to bending and denting. Its method of attachment leaves unsightly joints. Both of these conditions give vinyl siding an appearance that is uncharacteristic of wood siding.

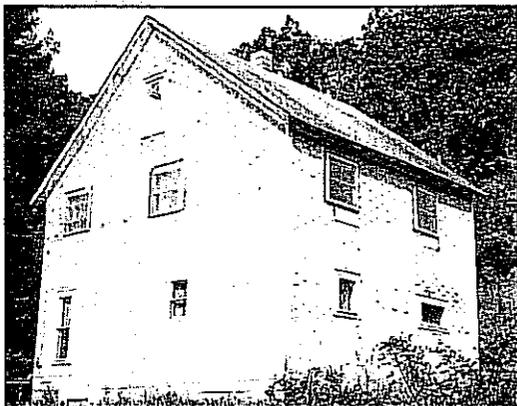
Over the years, a wide variety of materials has been used by property owners to cover wood siding in an attempt to gain relief from maintenance and repair. The pictures below illustrate how this practice significantly changes the appearance of historic resources, and show that such materials are generally not maintenance-free.

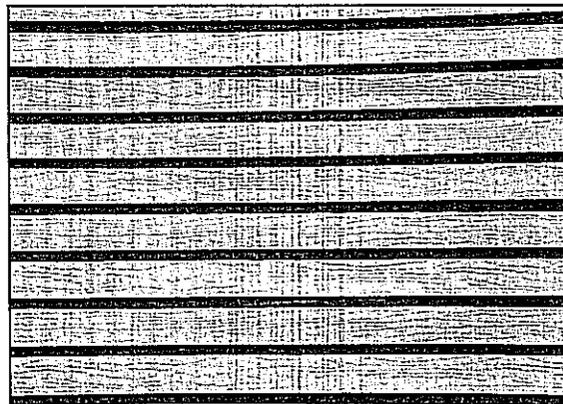
The simulated wood graining of this vinyl siding in Gettysburg does not make it a convincing substitute for wood siding.
